TOWNSHIP OF FRONTENAC ISLANDS
2022 OSIM INSPECTIONS FINAL SUMMARY REPORT
6 STRUCTURES

July, 2022

Prepared by John Landry, P.Eng

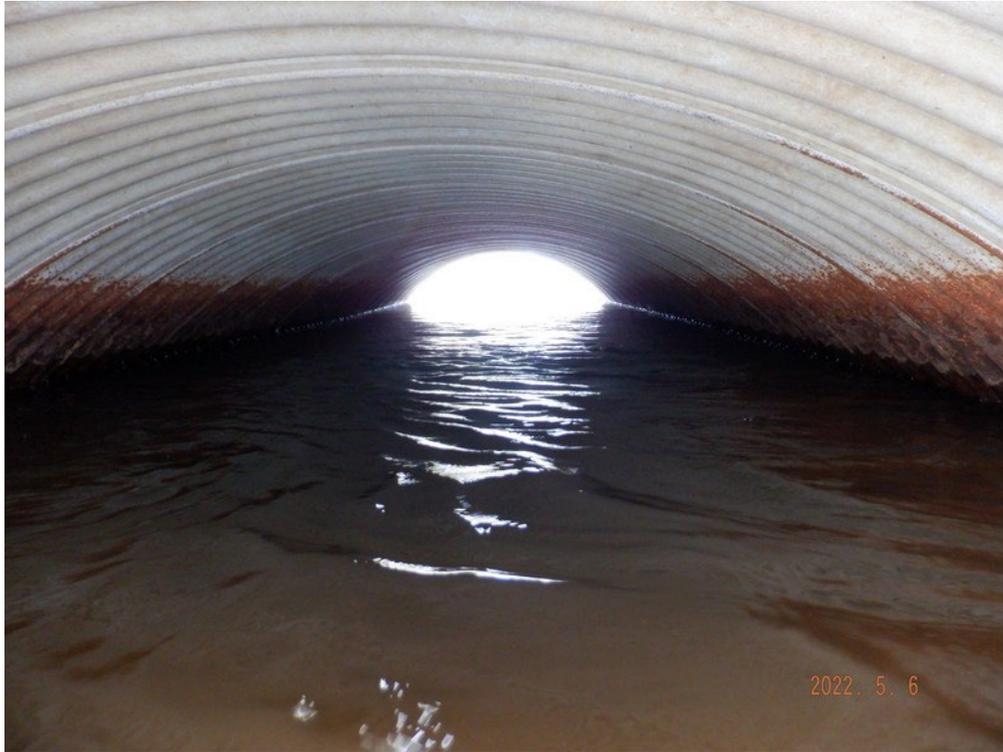
Special Notes: BCI 62.6
Corrosion at waterline and lack of clearance through the culvert indicate that an underwater investigation would be prudent within the next 10 years.

Looking through culvert from west

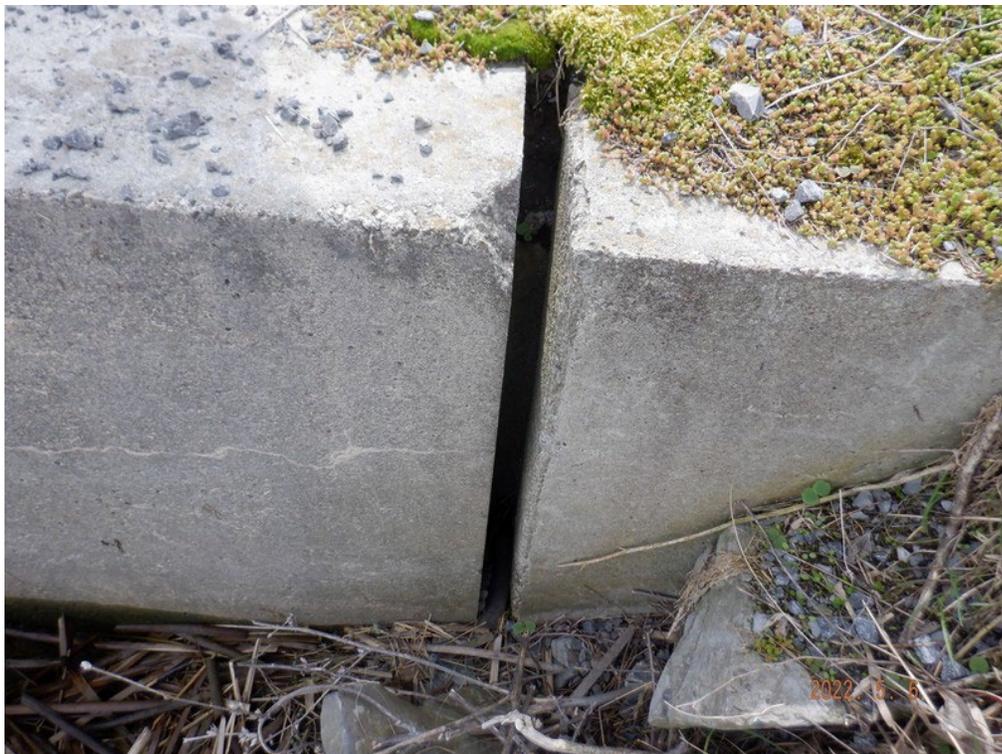
Wide gap at east joint

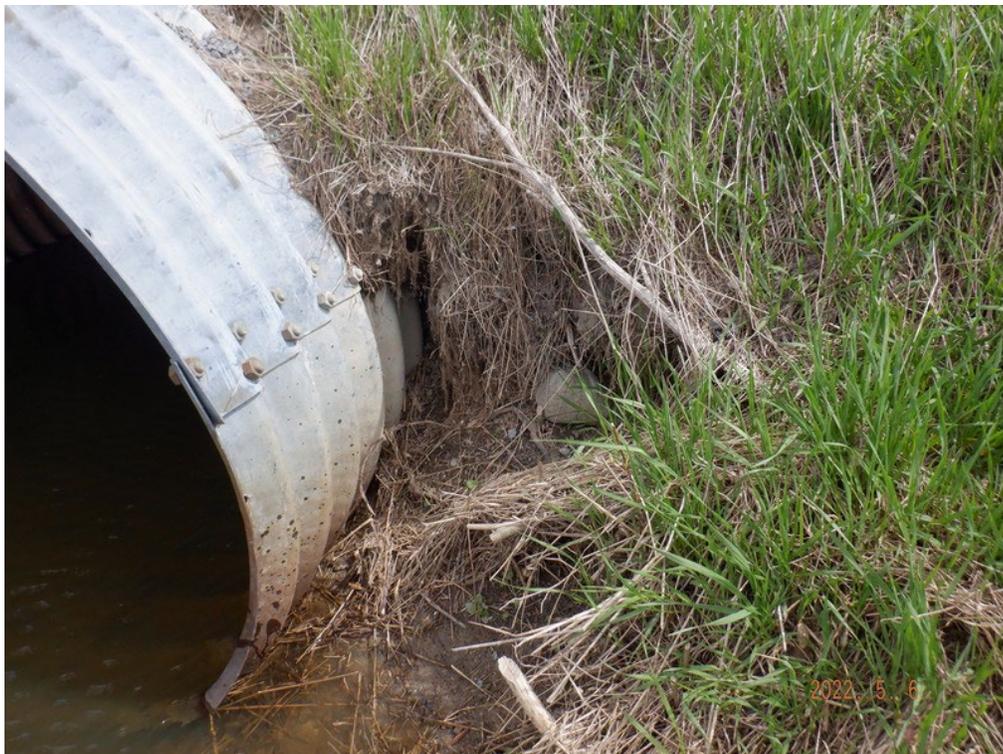
Erosion in South West

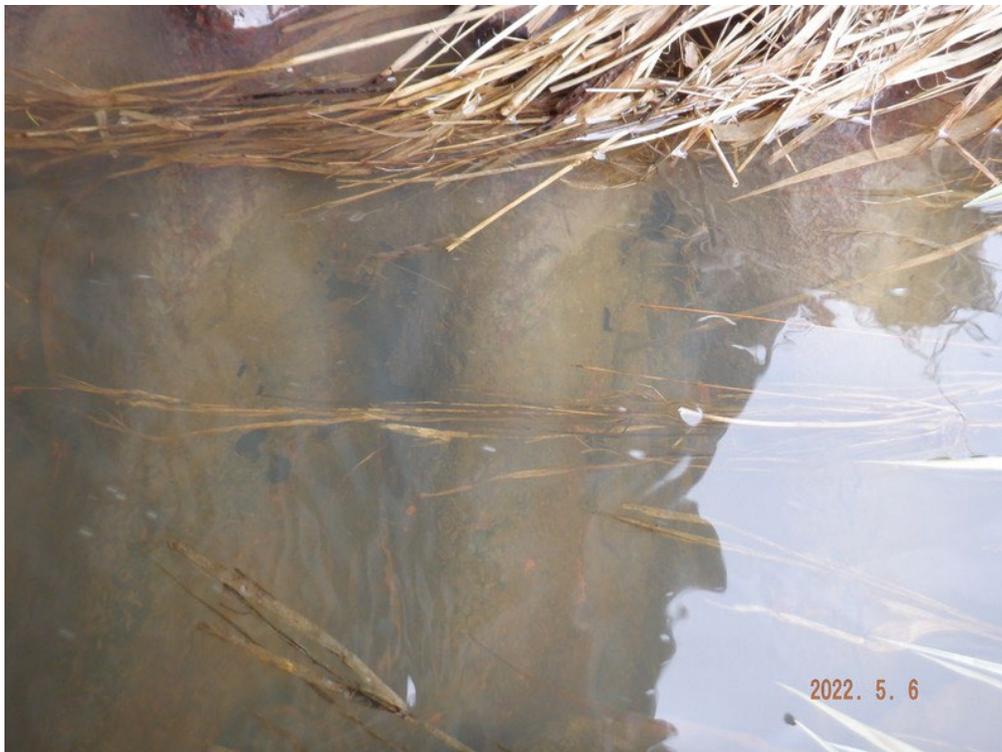
Generally the Township’s inventory is in good condition with a few exceptions. The 5th Line road culvert has started to display perforations. This is an early indication of severe section loss in the steel. Jewell Engineering recommends planning to replace this culvert within 10 years’ time.

Perforation in floor at east end

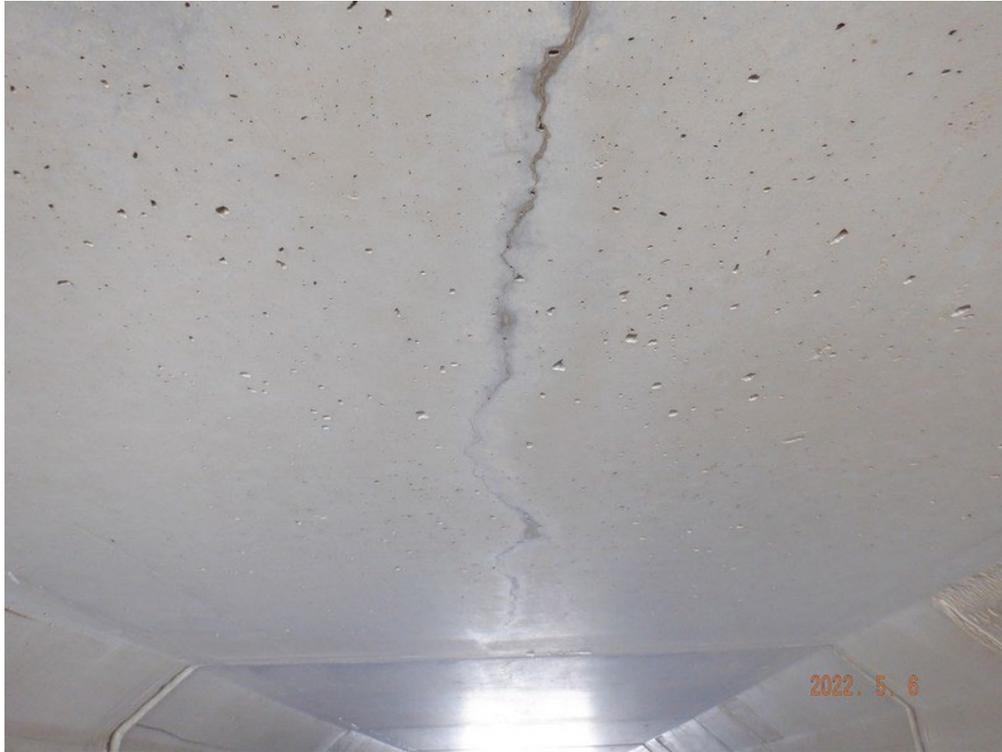
Narrow moisture crack in soffit
